FY 2017 Status of Sodium Freezing and Remelting Tests

Nuclear Engineering Division

Q. Lv, E. Boron, Y. Momozaki, D. B. Chojnowski, J. J. Sienicki, and C. B. Reed
Nuclear Engineering Division, Argonne National Laboratory

September 15, 2017

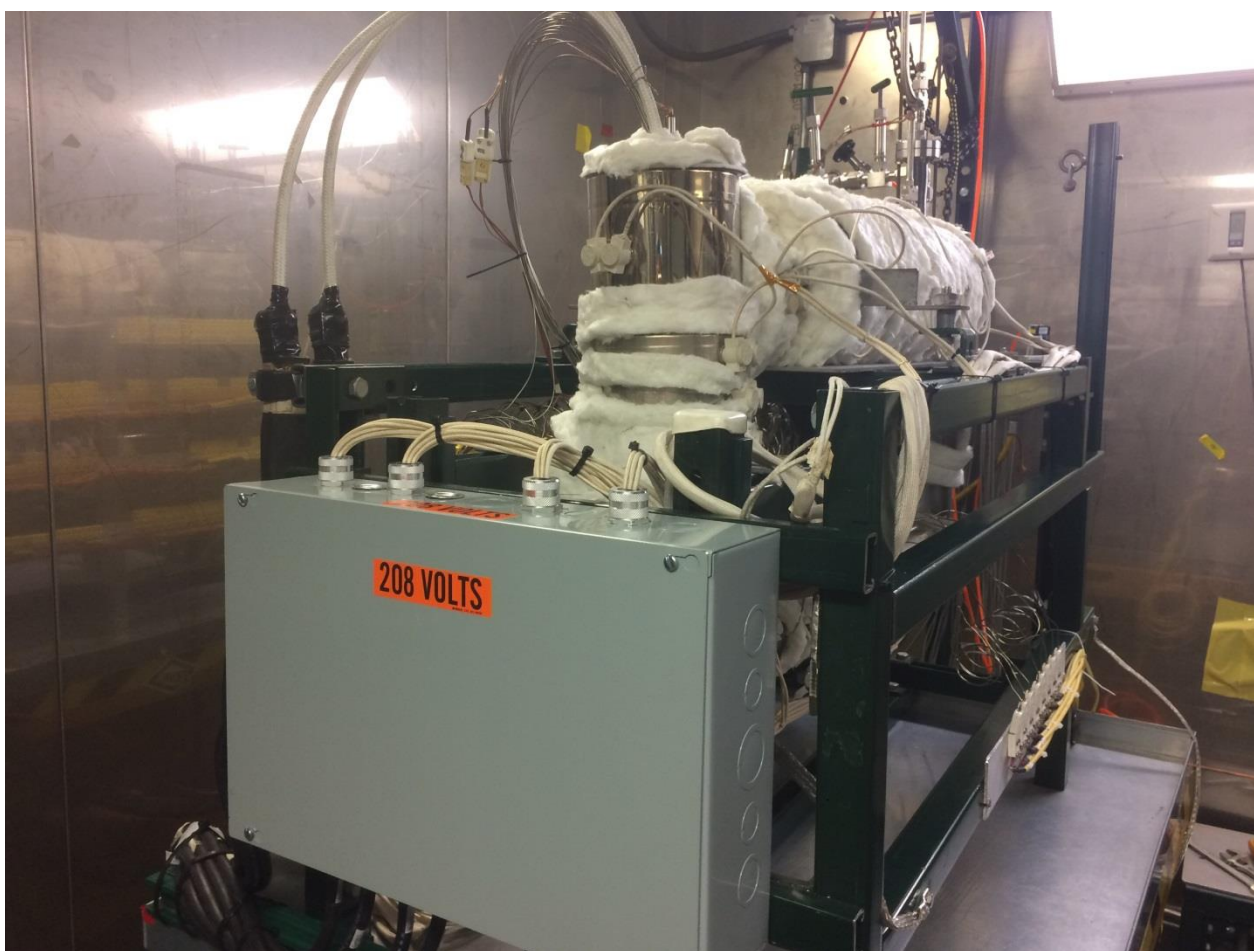
The Sodium Freezing and Remelting test facility is located inside an isolated enclosure cell, while the heating power supply and control system is located outside of that cell for heat shielding purpose. In the old test facility, the heater wires were connected to the power supply and control system through terminal blocks that were only covered with plastic covers and not well shielded. This was considered not safe, and it was decided to install an electrical enclosure to house the terminal blocks for better electrical shielding. A picture showing the installed electrical enclosure can be found in Figure 22.

Figure 22. Installed electrical enclosure for better electrical shielding

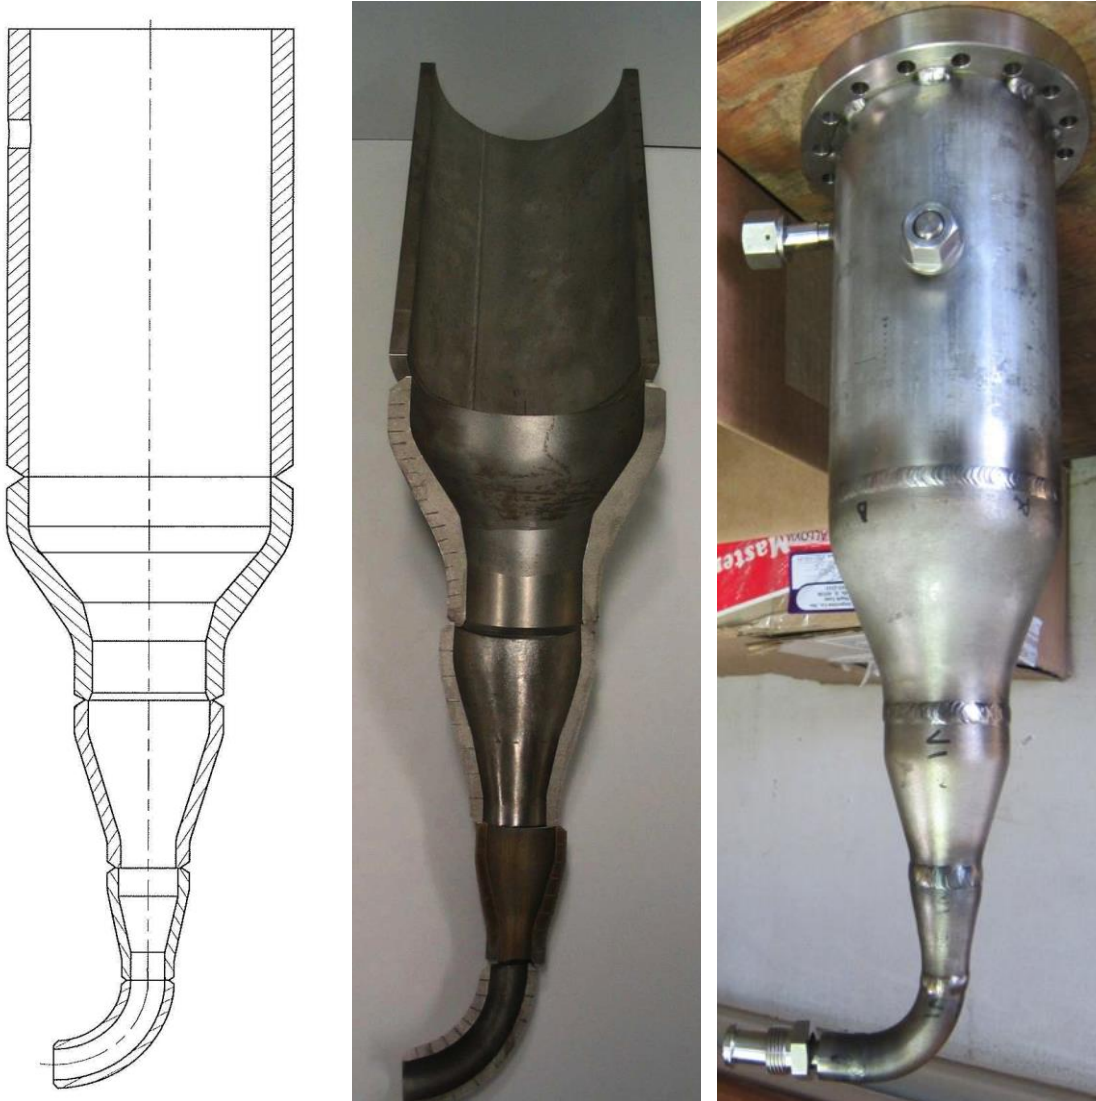
One of the components that was not modified during the upgrade of the Freezing and Remelting test facility is the sodium reservoir. Figure 23 shows a cross section of the reservoir and sections of each reservoir subcomponent beside a photo of the as-fabricated reservoir. The sodium reservoir serves mainly four purposes. First, sodium is initially loaded and subsequently added through the sodium reservoir. Second, the Freezing and Remelting test facility is not completely filled with sodium and there is some open space at the top of the reservoir. The test facility can be vacuumed or pressurized through the reservoir. Third, the reservoir houses the cold finger that will collect impurities when the sodium is in circulation and the cold finger is cooled with air. Last, when the test section or any other component in the test facility is to be removed, the sodium is drained into the reservoir by simply rotating the apparatus ninety degrees so that the reservoir is the lowermost component of the apparatus. The reservoir size (2 liters) as well as the volumes of the other components was sized so that the test section completely drains into the large reservoir when the apparatus is rotated, yet adequate sodium covers the EM pump electrodes when the test facility is back to its normal orientation.

Figure 23. Section View (Left), Sectioned Duplicates of Components Comprising the Sodium Fill Reservoir (Center) and Fabricated Reservoir (Right)

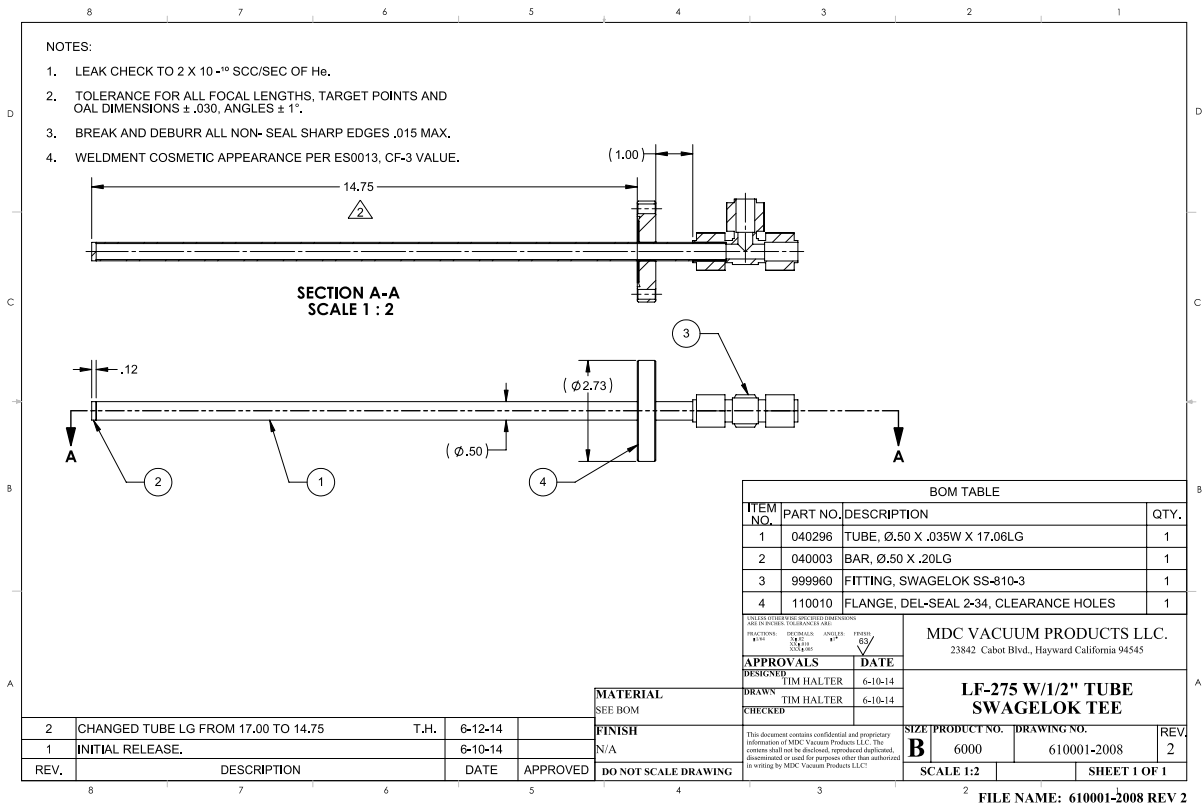
the temperature of the cold finger tube, thereby creating the coldest sodium-wetted surface inside the Freezing and Remelting test facility. After circulating the sodium for some time inside the Freezing and Remelting test facility while operating the cold finger, the main impurity in the sodium, oxygen, will be collected on the outer surface of the cold finger, thus purifying the sodium. The facility does not incorporate a sodium plugging meter or any other capability to actually determine the oxygen impurity level.

Figure 24. Cold finger fabrication drawing

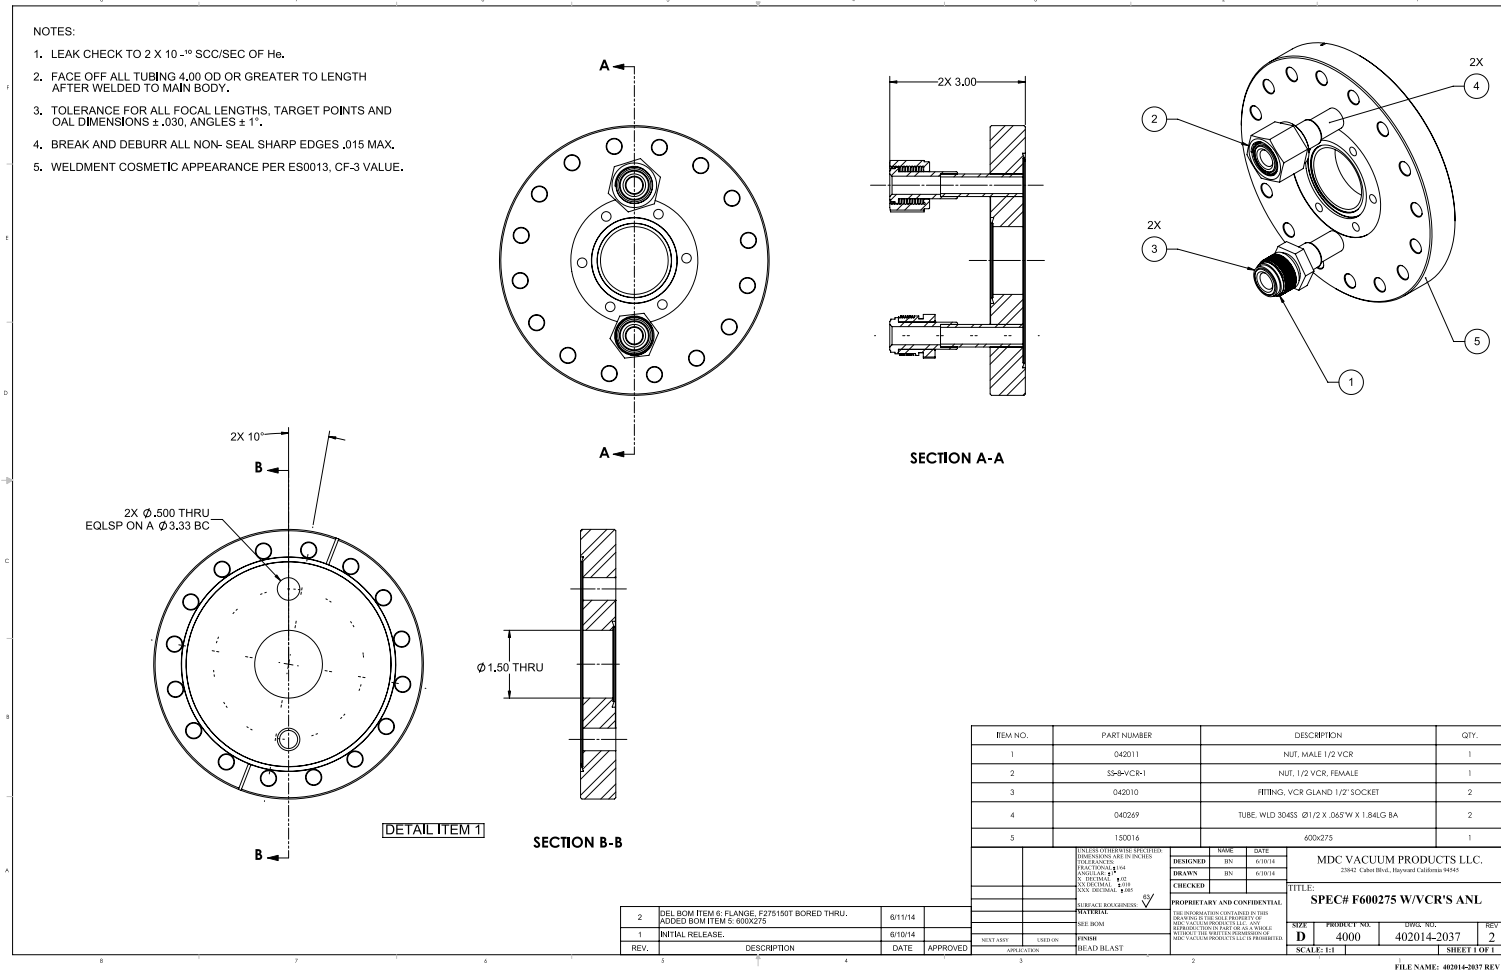
Figure 25. Cold finger top flange

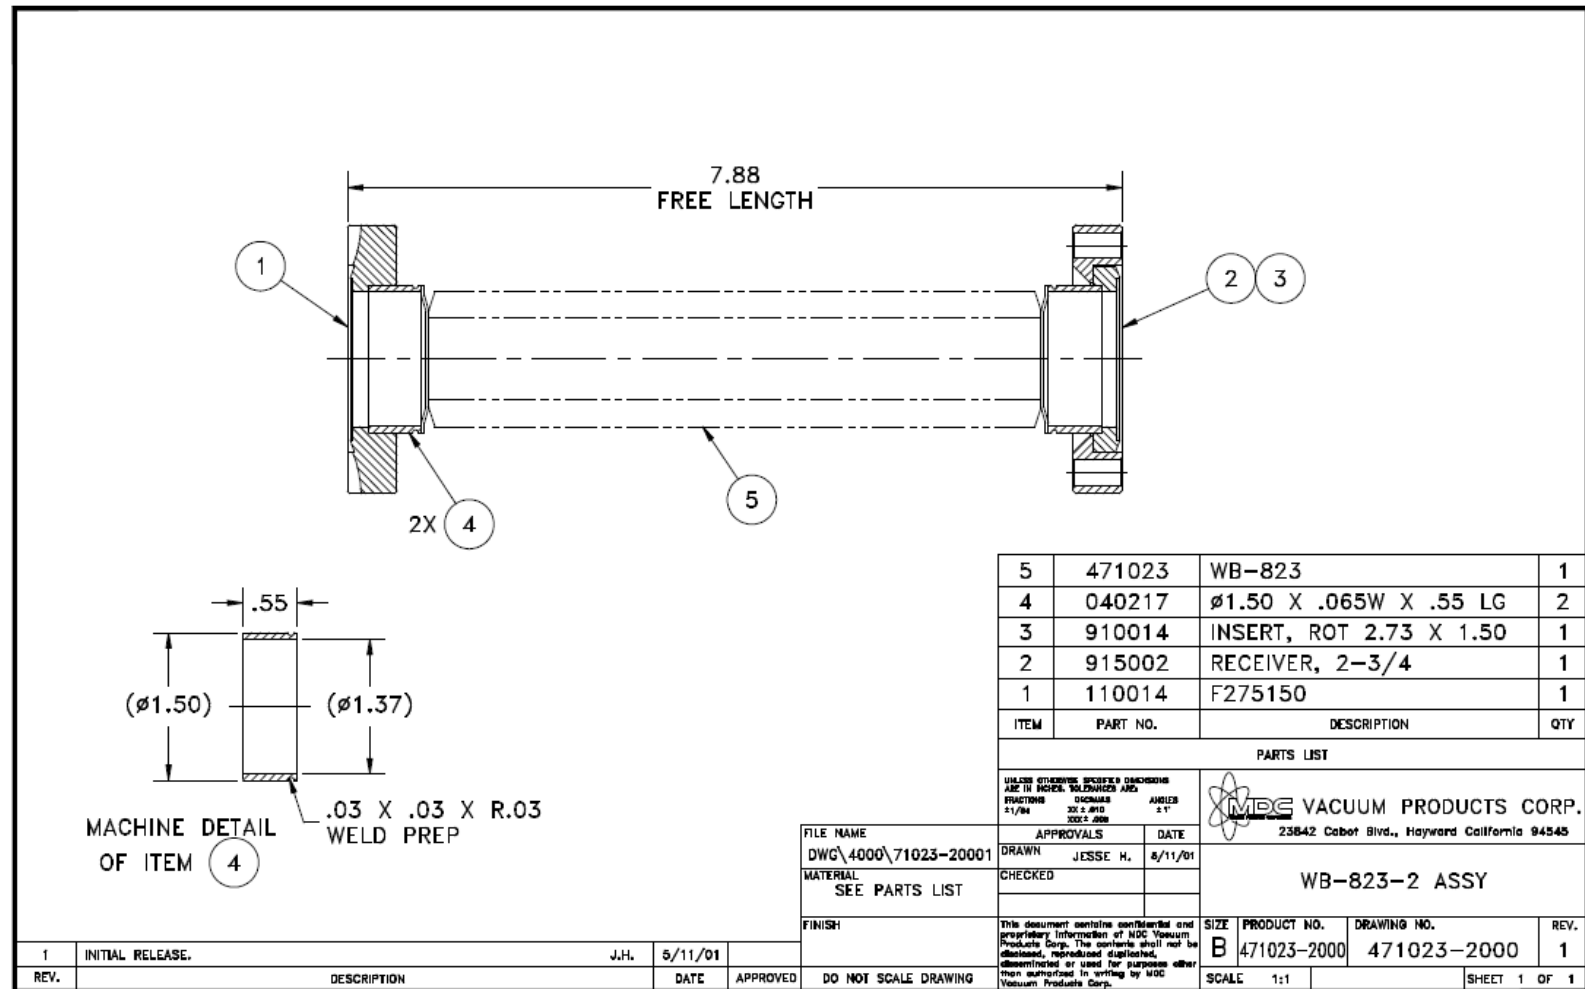
Figure 26. Cold finger bellows drawing

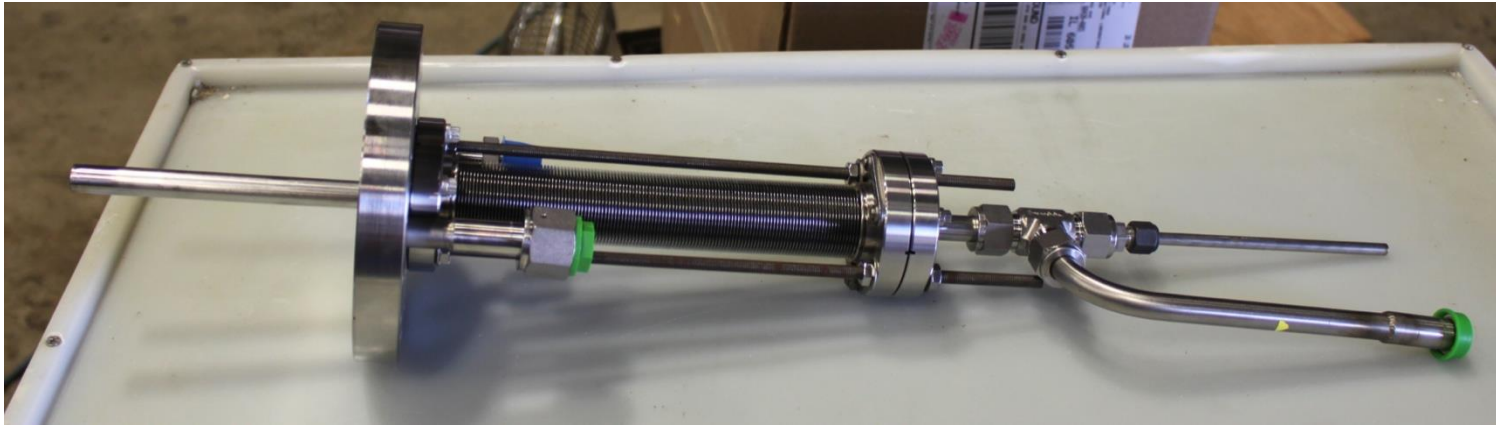
Figure 27. Cold finger assembly

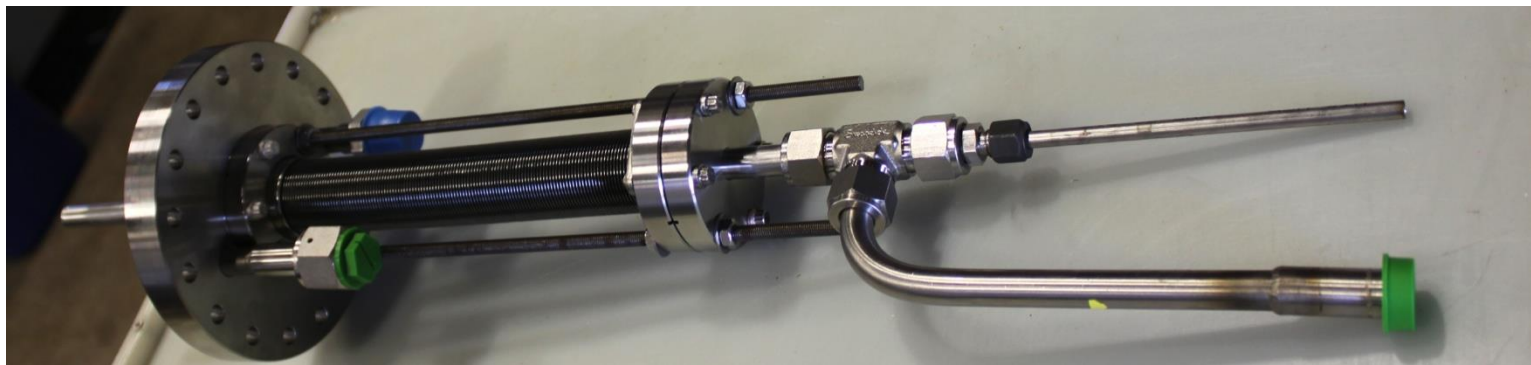
Figure 28. Cold finger top view

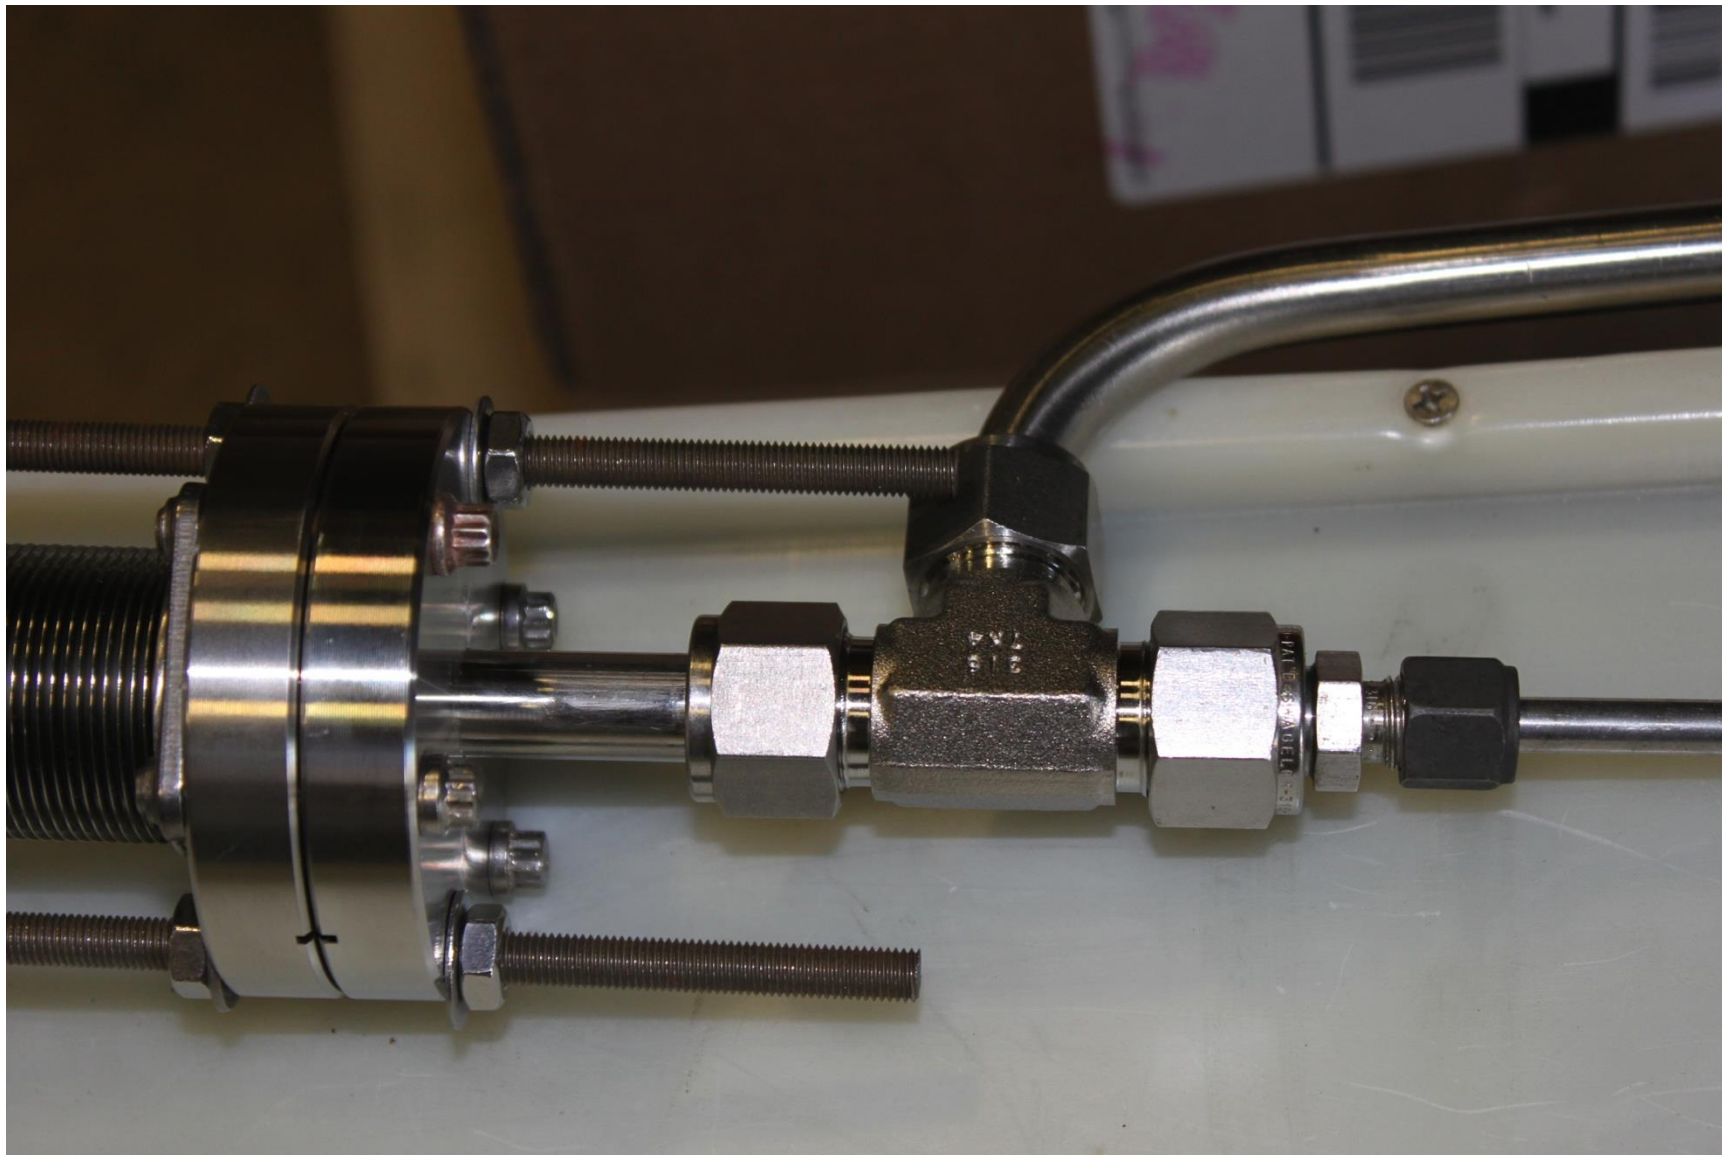
Figure 29. Cold finger air inlet/outlet

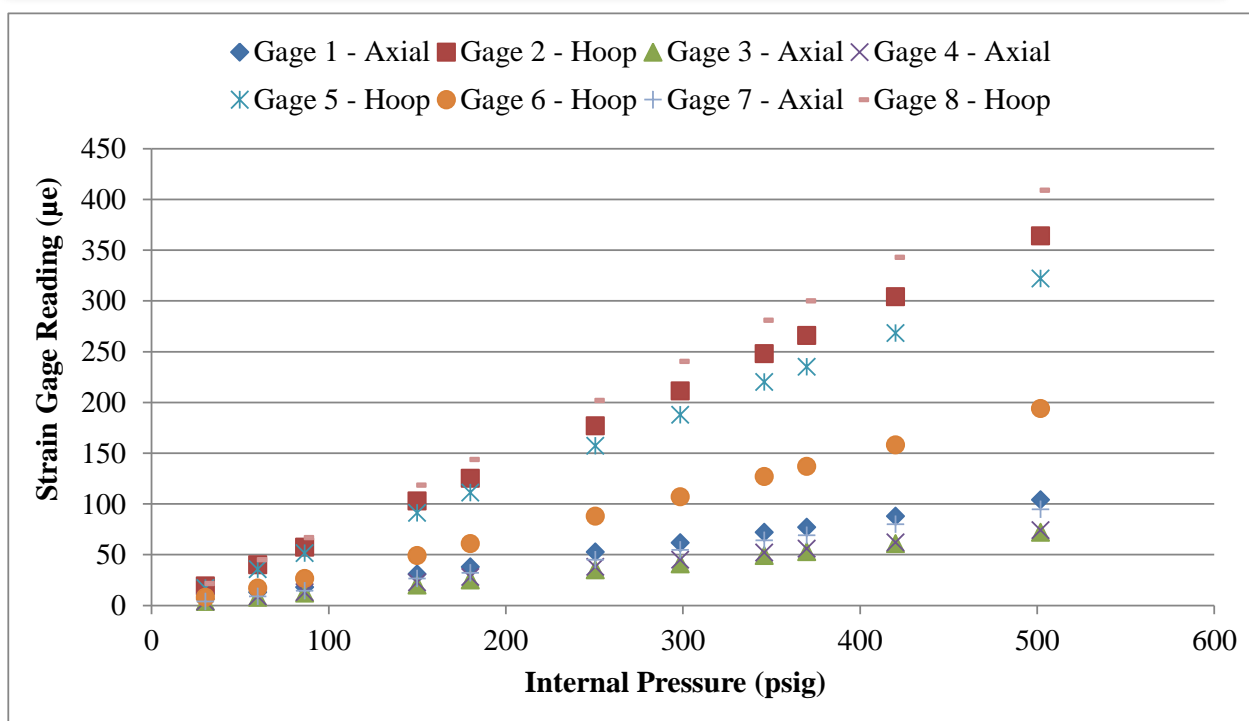
This test was performed to check the response of the strain gages to the internal pressure inside the test section. Pressurized water was used for this test due to safety concerns (to reduce the stored energy). For this test, the test section internal pressure was increased from atmospheric pressure to ~ 500 psig. All the strain gages were zeroed at atmospheric pressure before the test section internal pressure was increased. The test results are plotted in Figure 30. As can be seen, the response of the strain gages to the test section internal pressure is quite linear, indicating that the test stays in the elastic regime. Also, the strain readings separate themselves into roughly two groups, except for the outlier of Gage 6 reading. The hoop strains are much larger than the axial strains, which is understandable. Similar tests [5] were previously performed on the old thin wall test section. The test results shown here are consistent with those previous test results.

Figure 30. Strain gage pressure response test results

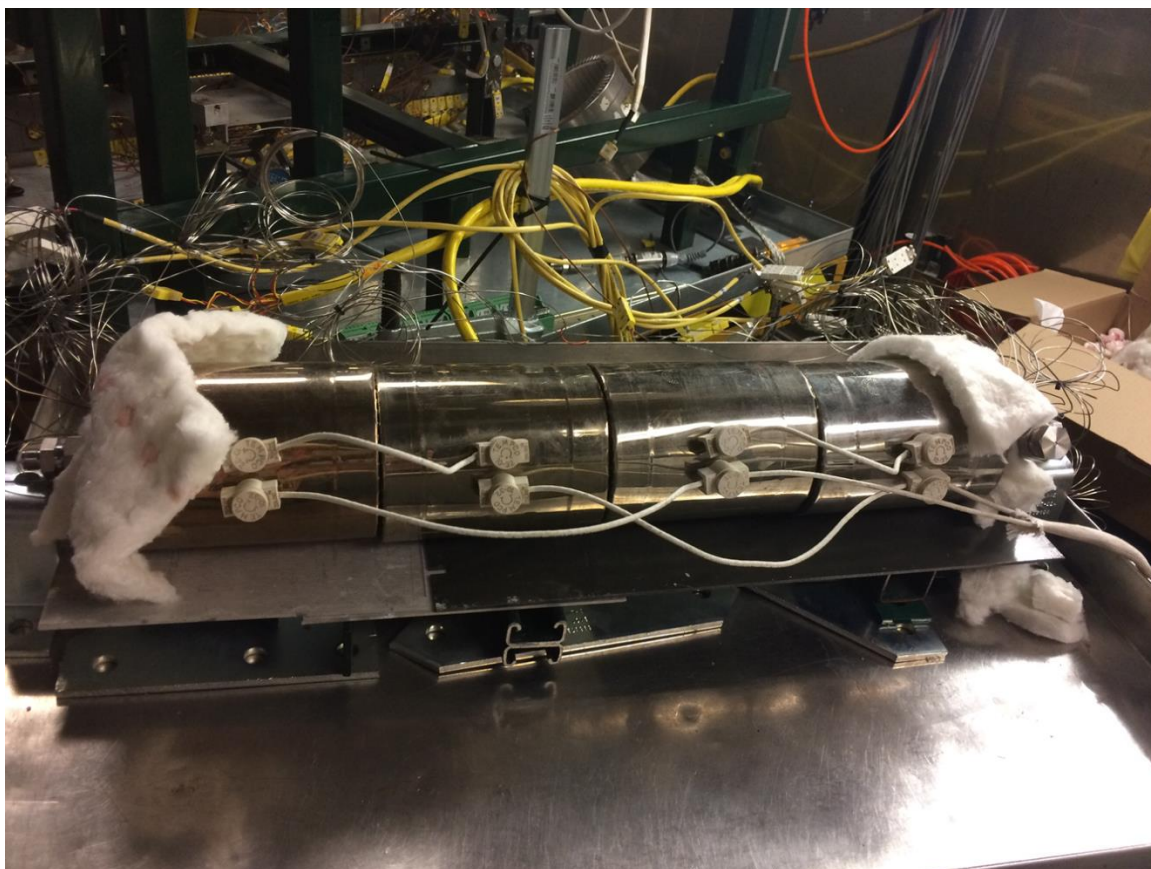
In addition to the strain gage balance test discussed earlier, the vendor also performed temperature response tests for the strain gages. Similar tests were performed on site. Figure 31 shows the setup of the tests. The test section was laid on the test bench with two ends free to expand. Ceramic band heaters were used for the heating with the two ends covered with ceramic fiber blankets. Adjustable supports were used at the two ends of the test section to ensure that the test section was concentric with the band heaters. The test results are shown in Figure 32 to Figure 34, along with the test data from the vendor. As can be seen, the agreement is good at low temperatures. At elevated temperatures, especially at $\sim 300^{\circ}\text{C}$, there are some discrepancies between the test data and vendor data. The vendor used a furnace for their tests, while ceramic band heaters were used for the on-site tests. Those discrepancies were probably due to the non-uniform heating in the on-site tests. Nevertheless, the overall agreement is good and acceptable.

Figure 31. Setup of the strain gage temperature response test

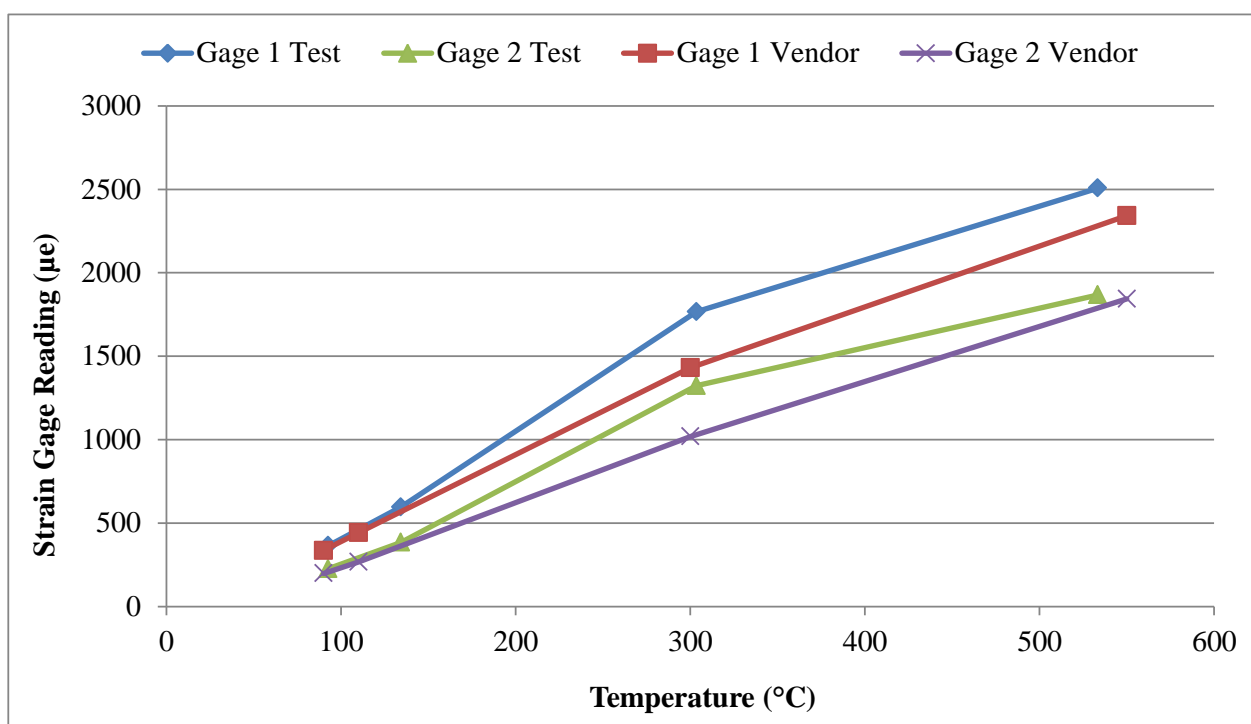
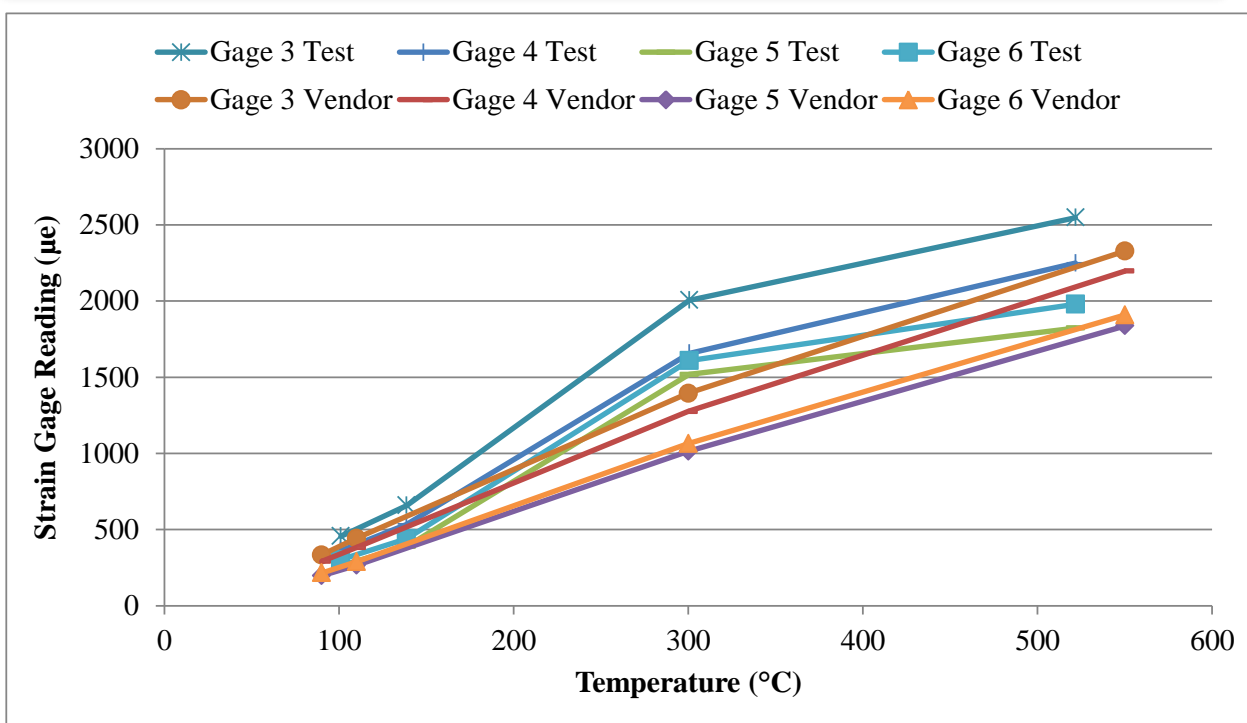
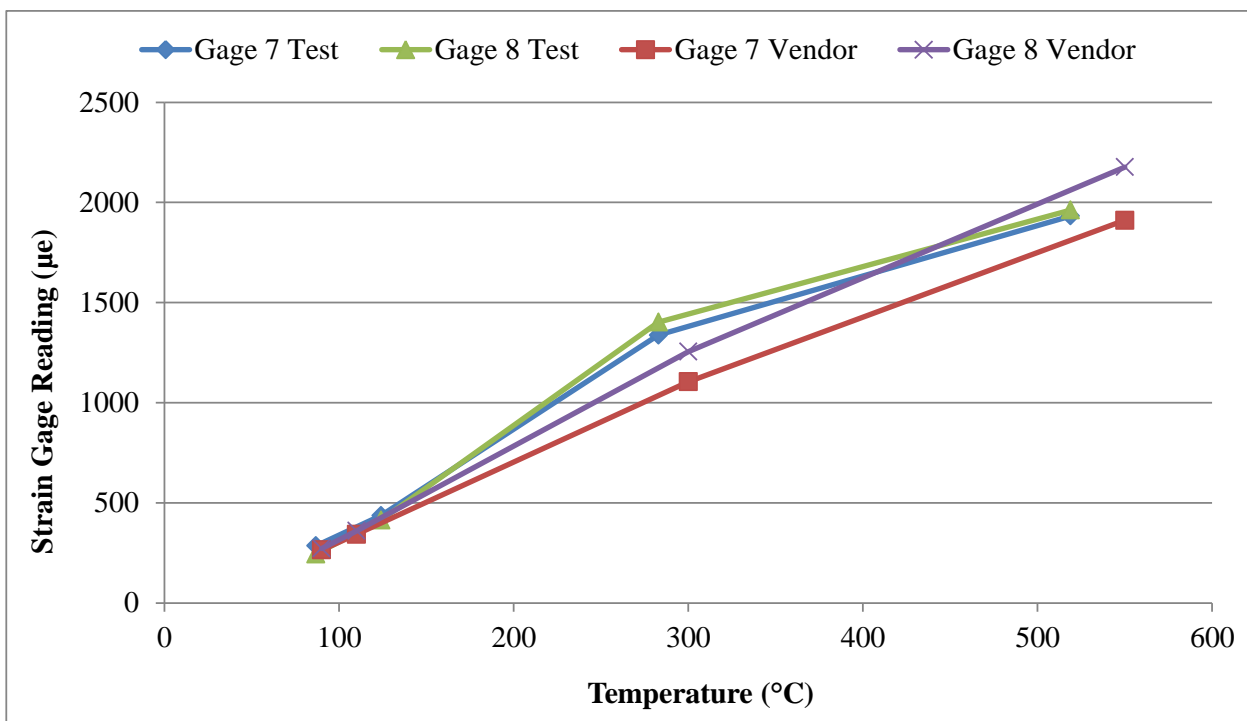
Figure 32. Temperature response test results for the two strain gages at + 4.8"

Figure 33. Temperature response test results for the two strain gages at the center

Figure 34. Temperature response test results for the two strain gages at -4.8"

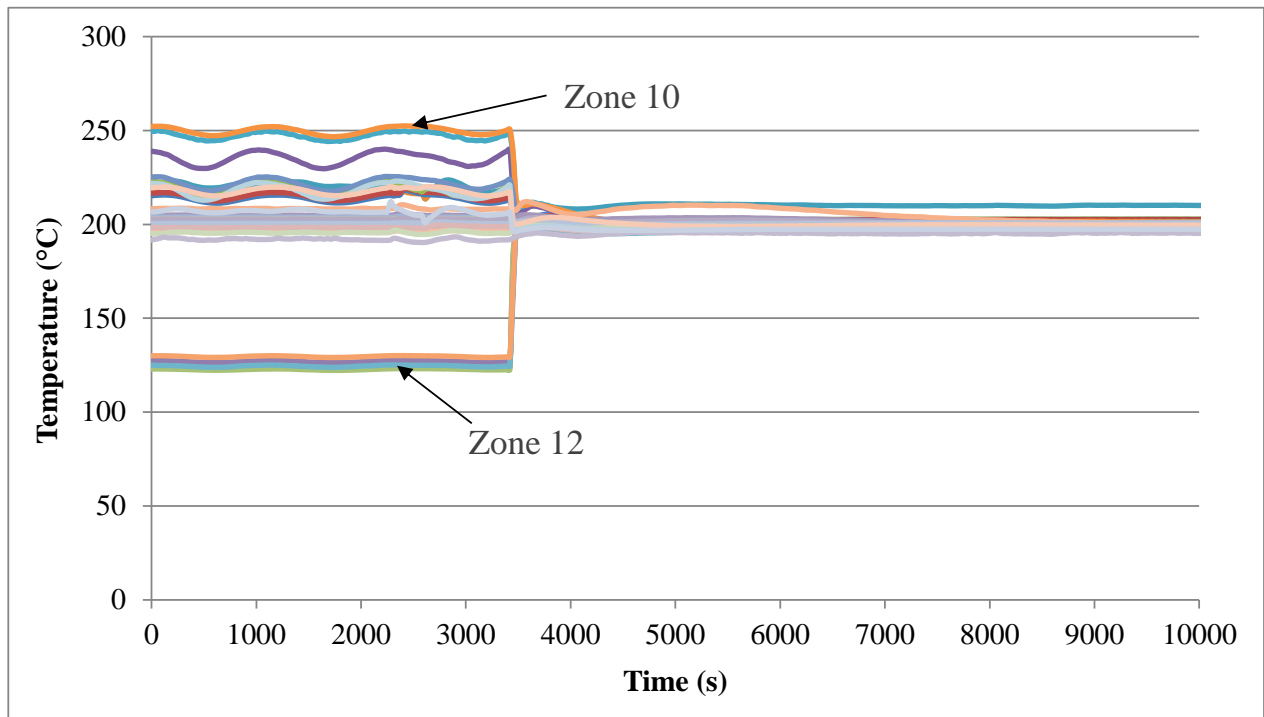
During the disassembly of the old test facility, glove bags were used when breaking a VCR connection to avoid causing significant contamination (oxidation) of the sodium inside the loop. Even though all the disassembly and reassembly work has been performed quickly and carefully, contamination is inevitable. The contamination can potentially cause plugging of the loop. Therefore, upon completion of the reassembly of the new test facility, it was decided to first perform a shakedown test, mainly to confirm and establish the sodium flow. In the present Sodium Freezing and Remelting test facility, there is no flow meter implemented. The only indirect way that has been employed to confirm sodium flow is intentionally heating the different zones (see Figure 20) to different temperatures. By turning on the EM pump, if a sodium flow exists, the different zone temperatures should converge to approximately the same temperature. In this shakedown test, Zone 10 was heated to $\sim 250^{\circ}\text{C}$ considering the heat sink of the EM pump magnets; Zone 12 was heated to $\sim 125^{\circ}\text{C}$; and the rest of the loop was heated to $\sim 200^{\circ}\text{C}$. Once the system temperatures stabilized (there were still some oscillations in the Zone 10 temperatures mainly due to the heat loss to the EM pump magnets and on-off controlling of the heaters), the EM pump was turned on. The system temperatures before and after turning on the EM pump are shown in Figure 35. As can be clearly seen, before turning on the EM pump, a temperature gradient exists along the loop. However, once turning on the EM pump, the system temperatures converge to approximately the same temperature of $\sim 200^{\circ}\text{C}$. This clearly demonstrates that a sodium flow has been established and the loop is operational.

Figure 35. System temperatures before and after turning on the EM pump

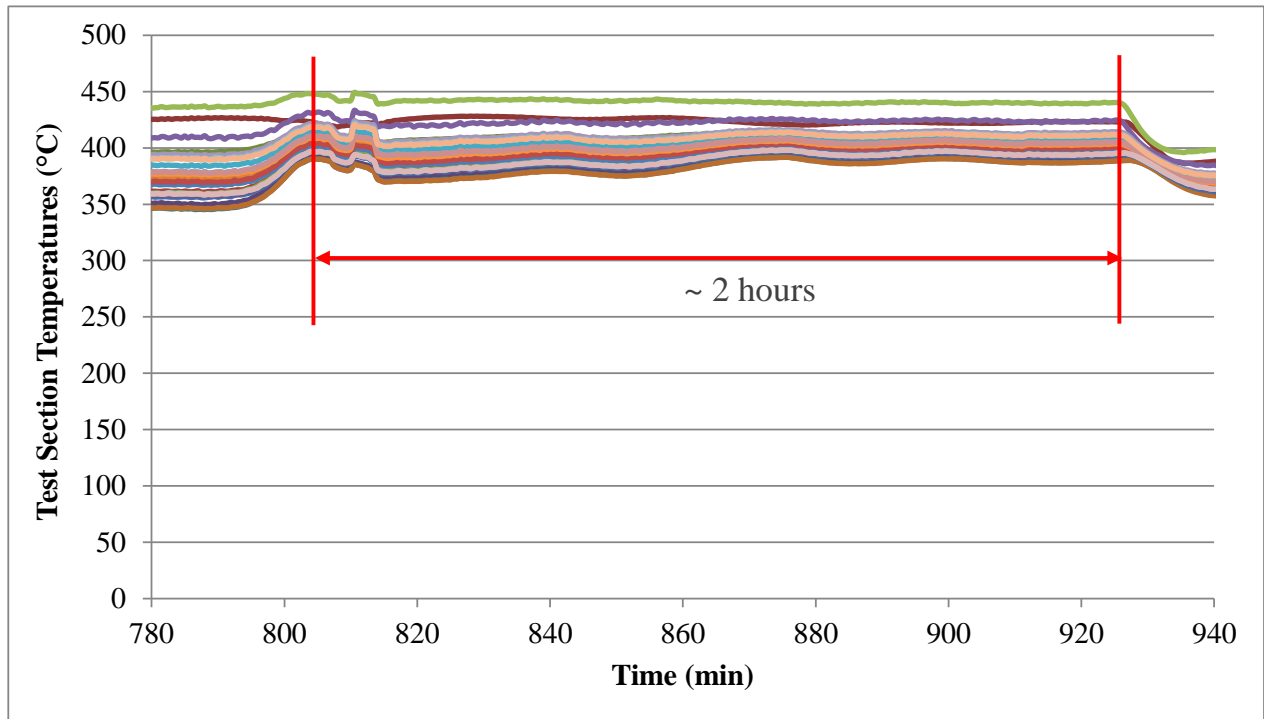
For this test, the loop was first evacuated to remove the cover gas at room temperature. This evacuation helped eliminate potential gas pocket formation in the test section as well as to reduce any dissolved gas in the sodium. It is known that the dissolved gas may become a seed of cavitation during the freezing. If such cavitation occurs, the expected inward pressure may be significantly reduced. The loop was then heated to melt the sodium from the free surfaces toward the center of the test section. Once the sodium was melted, the Zone 12 temperatures were raised to 125°C, Zone 10 temperatures to 225°C and the rest of the loop to 200°C. The EM pump was subsequently turned on, and the sodium flow was confirmed by observing the convergence of the loop temperatures. These steps were deemed as necessary to confirm sodium flow, and thus would be repeated for every future test. Once the sodium flow started, the cold finger was turned on by introducing cold air into it. The Zone 11 controller was then set to and fixed at a 150°C set temperature to keep it as the coldest region in the loop. This would ensure that the impurities deposit onto the cold finger in Zone 11, not any other region in the loop. The loop temperatures were then increased slowly in steps. With the cold finger on, there was competition between cooling and heating. Every time when the loop set temperatures (except for Zone 11) were increased, it took time for the system to stabilize and develop some temperature gradient. As the test continued and when the test section temperatures were raised to ~ 400°C, difficulties were encountered in controlling the loop temperatures. Large discrepancies in PID controller and limit controller readings were observed in Zones 3, 5, and 7. After a group discussion, it was concluded that the controlling thermocouples and heaters for those zones were not thermally coupled well, and improvement work would be needed to reposition those controlling thermocouples and heaters. It was then decided to stop increasing the system temperatures. The system was maintained at that state (~ 400°C in the test section) for approximately 2 hours (see Figure 36), before the sodium leak early warning system was triggered. When the warning system was triggered, immediate actions were taken to trace and identify the location of the VCR fitting indicating sodium leakage. The information from the warning system led to a VCR fitting in Zone 12. However, no smoke was observed at that location. Also, the heater controller set temperature was lowered for that specific zone, the temperatures there (read from both the warning system and data acquisition system) started to decrease. This did not appear to be a real sodium leak. To be cautious, it was decided to lower the system temperatures and perform a freezing test.

Figure 36. Test section maintained at ~ 400°C for ~ 2 hours

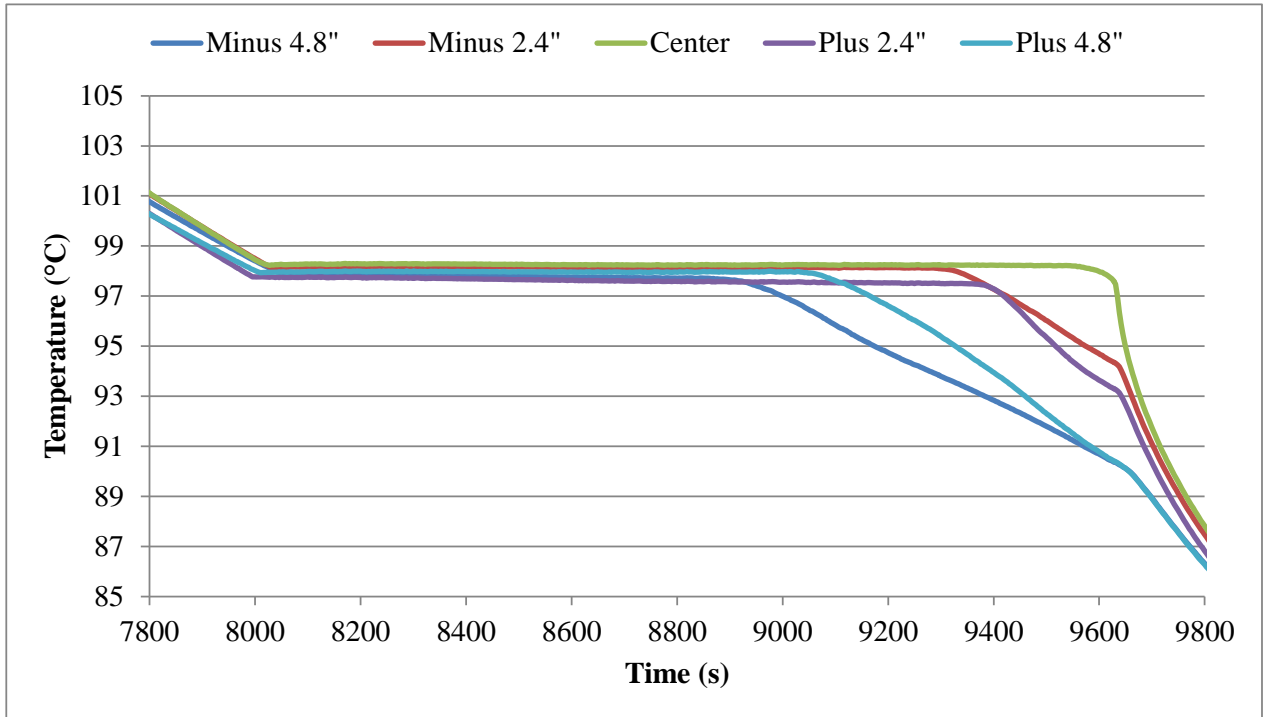
For the freezing test, the system temperatures were first lowered to ~ 110°C. The freezing was then started from the free surfaces by turning off the heaters in the corresponding zones (Zones 10 and 11). The free surfaces were first frozen so that the test section could detect the maximum strain change when sodium freezing occurred. When freezing started to occur in the test section, the freezing front was controlled to propagate from the ends of the test section toward its center, as shown in Figure 37.

Figure 37. Propagation of freezing front from the ends toward the center of the test section
